## Oil well blowout at Obed Wild and Scenic River

by Pat O'Dell and Rick Dawson

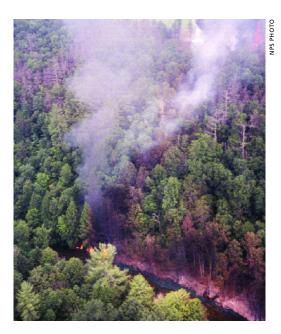
A fiery oil well blowout rages on a bluff above Obed Wild and Scenic River, dumping petroleum into Clear Creek in the national park. Scorched trees along the bank and pockets of burning oil are remnants of the fireball that roared through the valley hours earlier.

Renewed interest in prevention nearly always follows an accident of this size, and rightly so. Within days the State of Tennessee directed operators to use blowout prevention equipment and is now in the process of reviewing its entire oil and gas program to avoid a repeat disaster. The National Park Service will participate in that review process to ensure that park resources are protected. This action comes just in time, as news of the gusher has excited the oil and gas community and new wells are already being drilled in drainages near the park. The balancing act continues. ■
